DEPARTMENT OF TRANSPORTATION**DIVISION OF ENGINEERING SERVICES**

Office of Structural Materials

Contract #: 04-0120F4Cty: SF/ALA Rte: 80 PM: 13.2/13.9File #: 99.28**WELDING INSPECTION REPORT****Resident Engineer:** Pursell, Gary**Address:** 333 Burma Road**City:** Oakland, CA 94607**Report No:** WIR-002356**Date Inspected:** 29-Apr-2008**Project Name:** SAS Superstructure**OSM Arrival Time:** 830**Prime Contractor:** American Bridge/Fluor Enterprises, a JV**OSM Departure Time:** 1830**Contractor:** Japan Steel Works, Ltd.**Location:** Muroran, Japan**CWI Name:** Chung Kuan**CWI Present:** Yes No**Inspected CWI report:** Yes No N/A**Rod Oven in Use:** Yes No N/A**Electrode to specification:** Yes No N/A**Weld Procedures Followed:** Yes No N/A**Qualified Welders:** Yes No N/A**Verified Joint Fit-up:** Yes No N/A**Approved Drawings:** Yes No N/A**Approved WPS:** Yes No N/A**Delayed / Cancelled:** Yes No N/A**Bridge No:** 34-0006**Component:** Tower, Jacking and Deviation Saddles**Summary of Items Observed:**

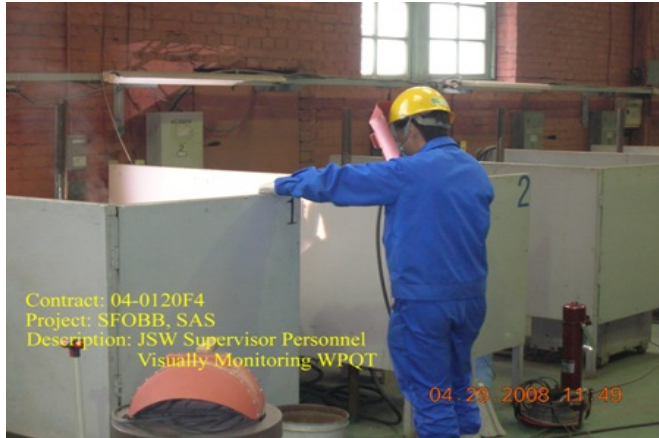
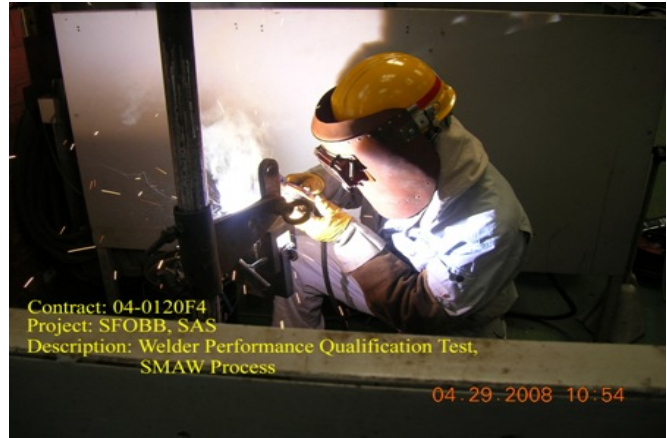
The material used for the welder performance qualification test specimens was reported by JSW Welding Engineer Mr. Takaaki Maruya as ASTM A709M-Gr.345T (plate to plate) having a material thickness measured at 25 mm. The weld joint design utilized appeared to be in compliance with the AWS D1.5-2002 Joint Designation identified as B-U2a (SMAW), B-U2a-GF (FCAW), Section 5 paragraph 5.23.1.2 and Figure 5.17 with a 10mm x 25mm backing bar. The filler metal and the shield gas utilized for FCAW process appeared to be TM-95K2 with an electrode size of 1.6 mm and the gas shielding utilized was 100% CO2 medium. The filler metal utilized for the SMAW process appeared to be Hoballoy E9018-M with an electrode size of 4.0 mm. The filler metal utilized appeared to comply with the contract documents. The welding and welding parameters were monitored and

recorded by CWI inspector Chung Kuan and JSW Welding Engineer Mr. Takaaki Maruya, and were also observed by this QA inspector. The QC inspector, Mr. Chung Kuan performed the visual inspection of the six (6) test plates and visually accepted five (5) of the six (6) test plates. The welder, Yuji-Sugawara failed the visual inspection of the SMAW test plate which was noted by Mr. Chung. Based on a random QA observation, the WQRT appeared to be in general compliance with the requirements of AWS D1.5 2002. (See Digital Photographs)
